Manhole Inspection Summary

Manhole # S27A1_013MH

Insp Date: **4/22/08 12:43 PM**

Location Address: **BEHIND 2047 ANNAPOLIS RD.**

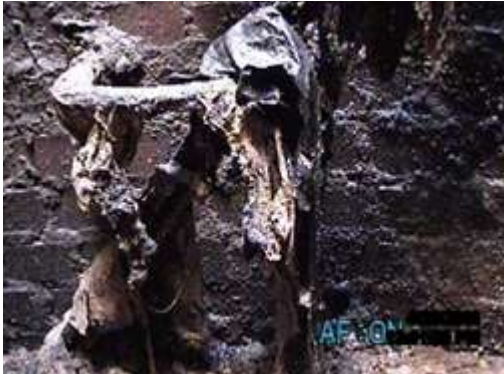
Defect 6

Steps Count: **6** Missing: **0** ☒ **Corroded**

Surcharge ☒ **Evidence Of Surcharge** Depth: **3** (ft.) ☐ Active Surcharge Present

evidence of surcharge, corroded step

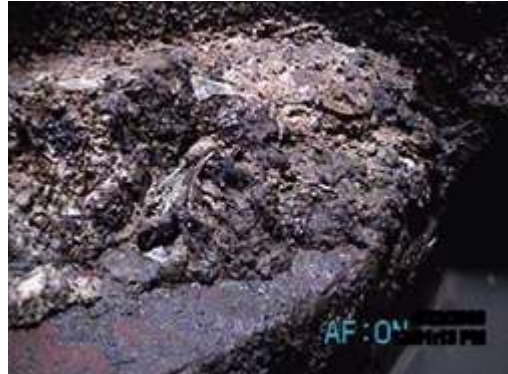
Defect 2

Condition: ☐ Sound ☐ Cracked ☐ Root Intrusion ☐ Deteriorated ☐ Leaks ☒ **Debris**

bench debris

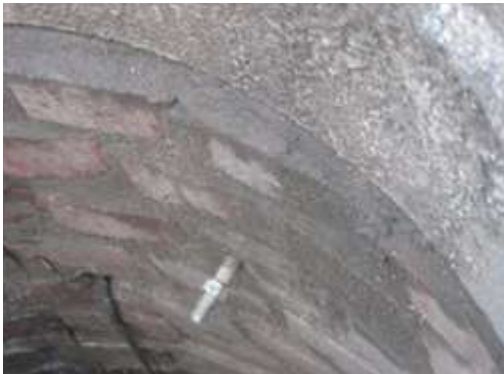
Defect 3

Infiltration: ☐ None ☐ Joint ☐ Cracks ☒ **Mortar** ☐ Roots ☒ **Wall**

signs of infiltration at corbel mortar & wall

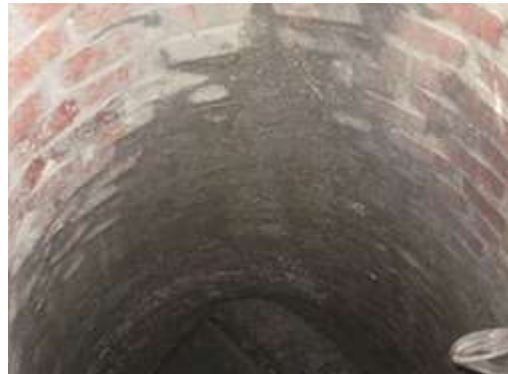
Defect 8

Infiltration: ☐ None ☐ Joint ☐ Cracks ☐ Mortar ☐ Roots ☒ **Wall**

signs of infiltration on barrel walls

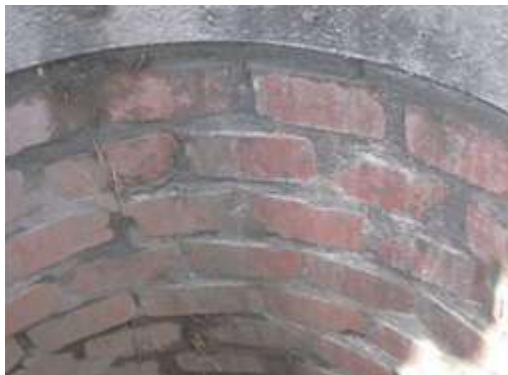
Defect 1

Infiltration: ☐ None ☐ Joint ☐ Cracks ☒ **Mortar** ☐ Roots ☐ Wall

signs of infiltration at chimney mortar

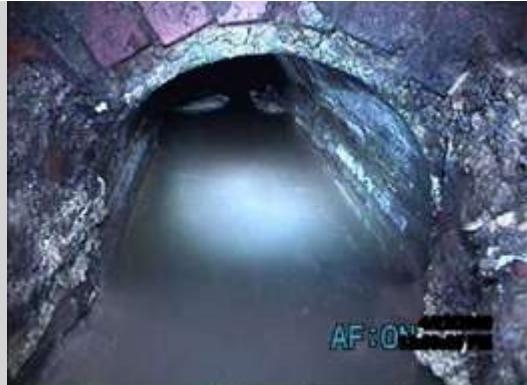
12 O'Clock Outflow

Pipe Height: **15.6** (in.) Rod and Bar (Angled)
Pipe Material: **Clay** ☐ Pipe Lined
Invert Depth: **11.78** (ft.) Flow Characteristics: **None**
Deposits: ☒ None ☐ Mud ☐ Sludge ☐ Debris ☐ Grease
Silt Depth: **0** (in.) Deposits Extent:
Infiltration: **Evidence** Pipe Seal Cond: **Unknown**

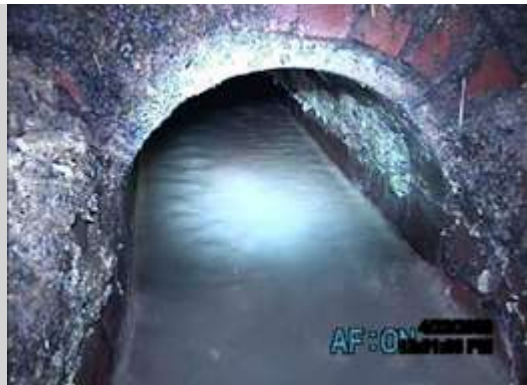
6 O'Clock Inflow

Pipe Height: **18** (in.) Rod and Bar (Angled)
Pipe Material: **Clay** ☐ Pipe Lined
Invert Depth: **11.92** (ft.) Flow Characteristics: **None**
Deposits: ☒ None ☐ Mud ☐ Sludge ☐ Debris ☐ Grease
Silt Depth: **0** (in.) Deposits Extent:
Infiltration: **Evidence** Pipe Seal Cond: **Unknown**
